Project Acronym: D^2EPC

Project Full Title: Next-generation Dynamic Digital EPCs for Enhanced Quality and User Awareness

DELIVERABLE D5.3

Pilot Planning and Setup v1

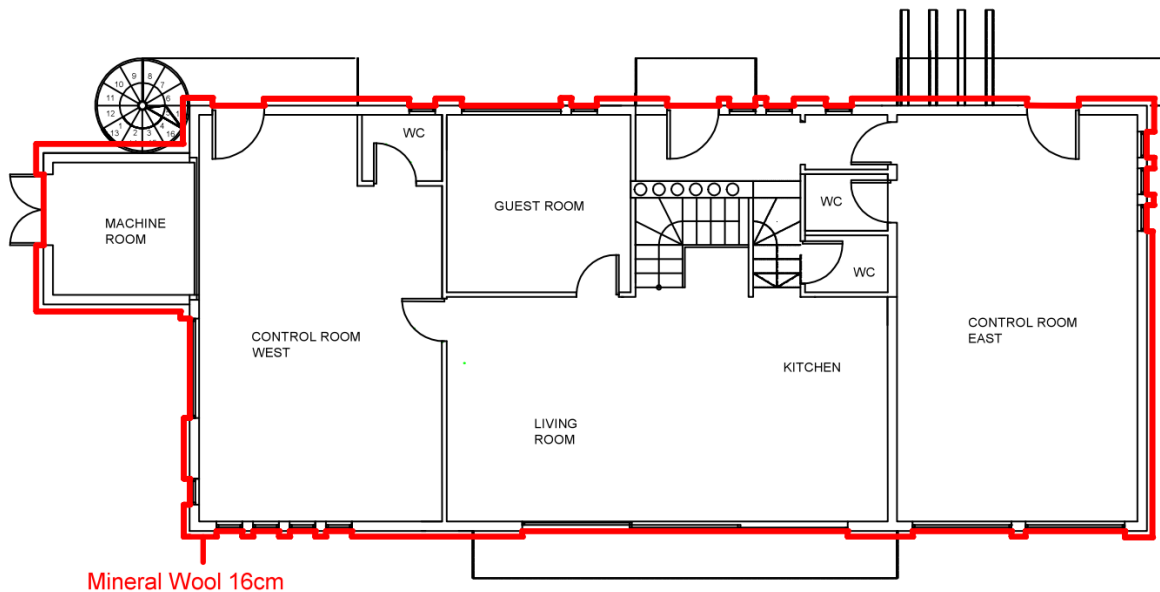
The structural elements (columns and beams), have an additional insulation layer under the mineral wool. For this purpose, 10 cm of XPS has been installed to lower the thermal transmittance to 0.13 $\text{W}/(\text{m}^2\text{K})$. Furthermore, the wall in contact with the machine room of 11 m^2 area, is also insulated in the same way as described above. The machine room's external walls are insulated with 10 cm of mineral wool, externally, and their thermal transmittance is equal to 0.3 $\text{W}/(\text{m}^2\text{K})$.

Figure 9: Insulation of vertical building elements - Ground floor plan

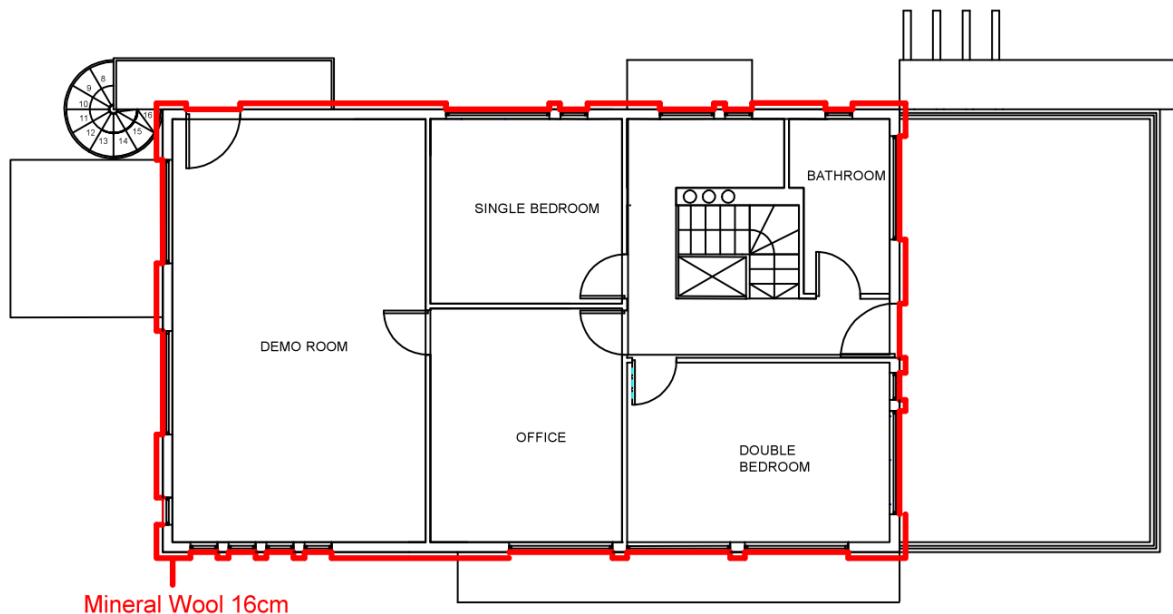
Figure 10: Insulation of vertical building elements - First floor plan

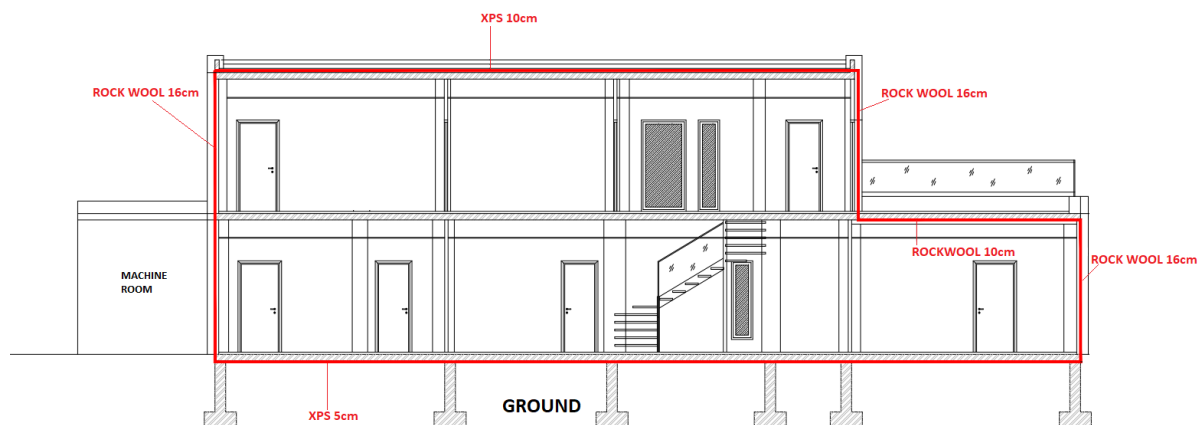
The remaining outer part of the building that will be examined for its thermal behaviour is the ground floor. The total floor area in contact with the ground is 192.6 m², but only 182.7 m² is insulated; the floor of the machine room is uninsulated, as it is a non-conditioned space. The protected part of the floor-slab was insulated with 5 cm of XPS, which has a thermal conductivity value equal to 0.033 (W/(m·K)) and anti-seismic properties. The resulted thermal transmittance is 0.554 W/(m²K). The insulation layer is installed at the external side of the floor (in contact with the ground), to reduce heat transfer to the ground.

Figure 11: Smart House insulation layout

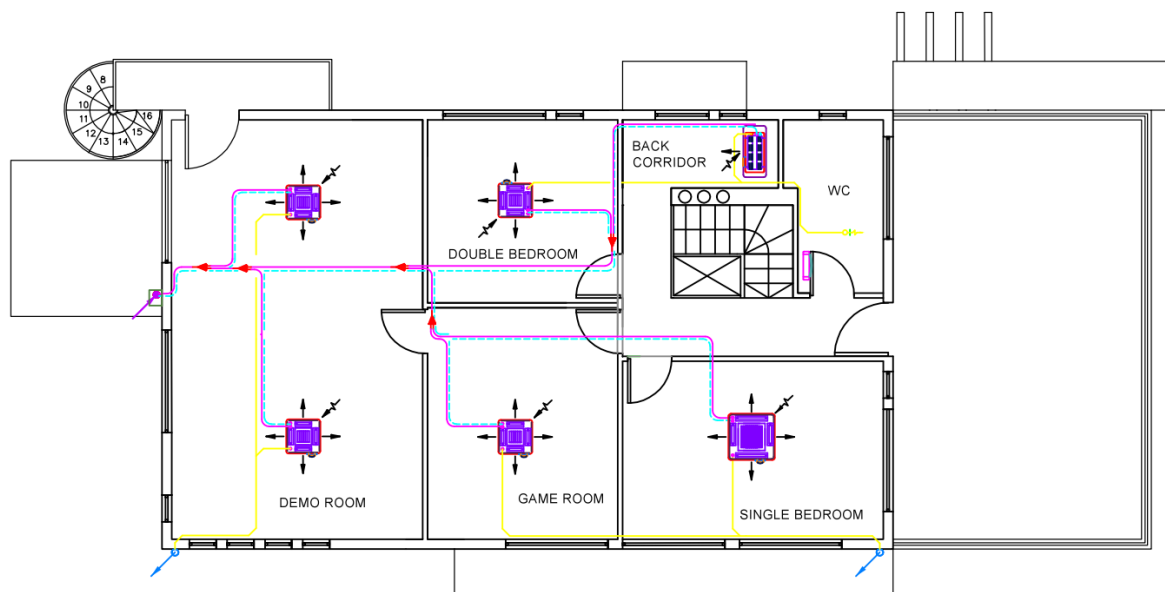
Figure 16: Smart House first floor-plan / HVAC

The deployment of the terminal units, the distribution system and the heat production units are presented below (Figure 16, 17).

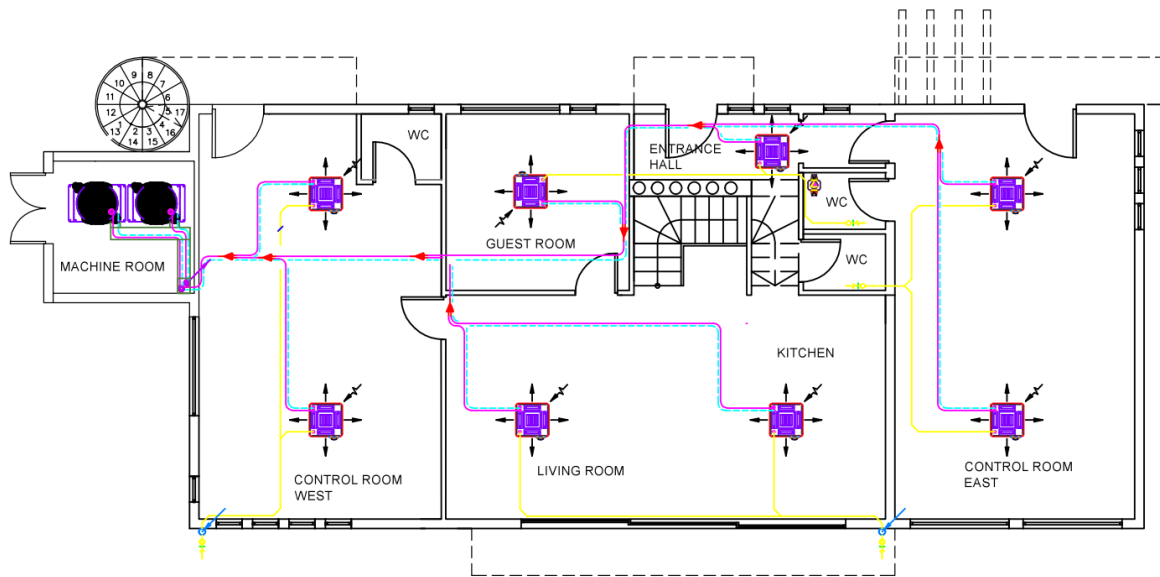
Figure 17: Smart House ground floor-plan / HVAC

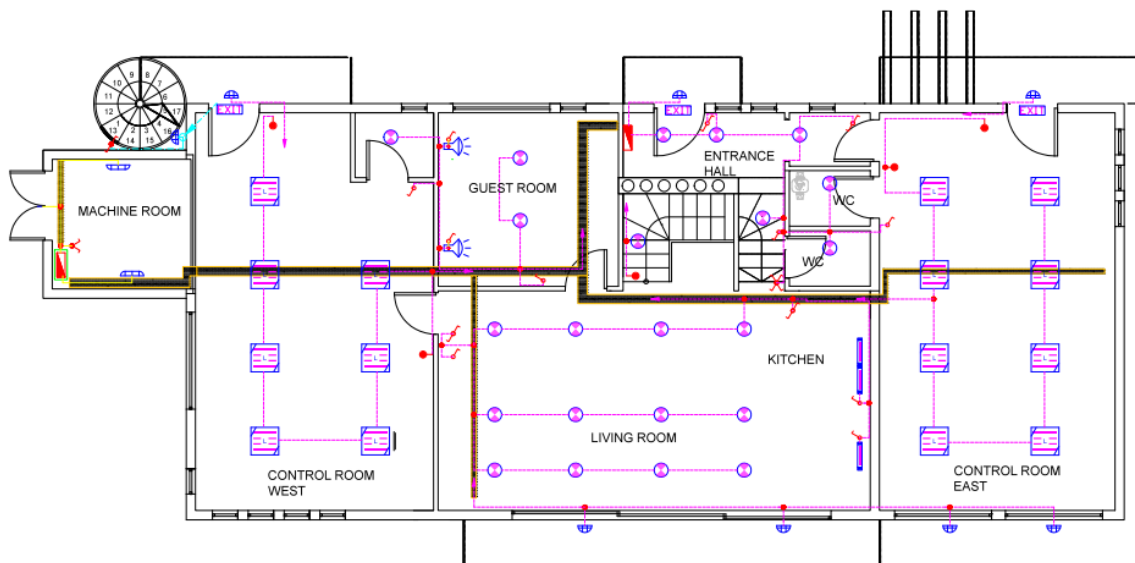
Figure 19: Smart House ground floor-plan / lighting

The allocation of the lighting equipment is presented in Figures 19 and 20.

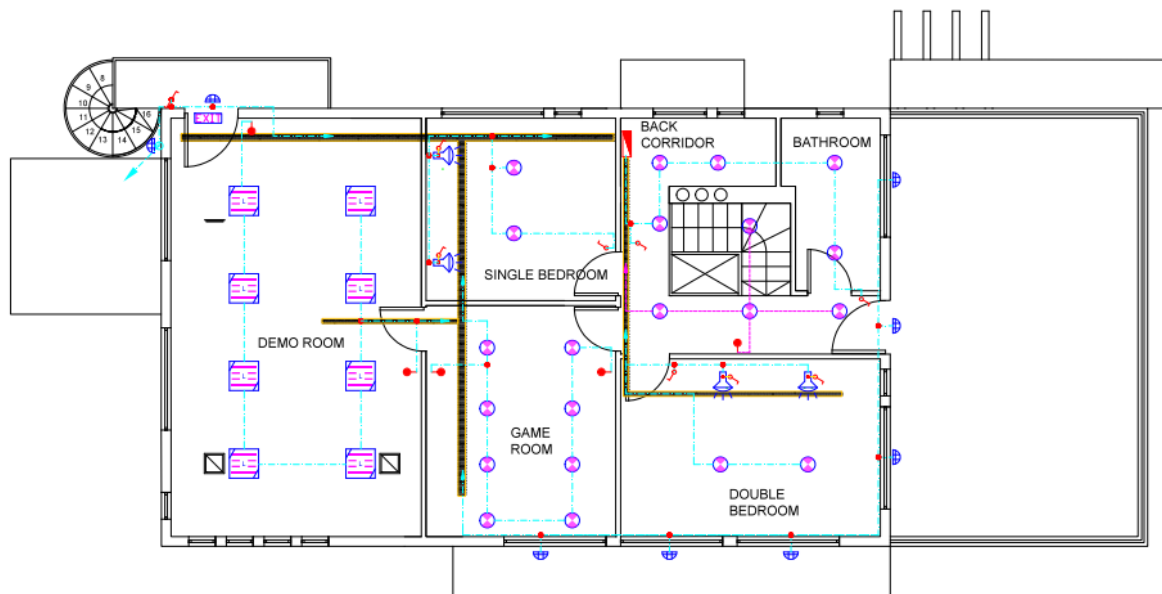
Figure 20: Smart House first floor- plan / lighting

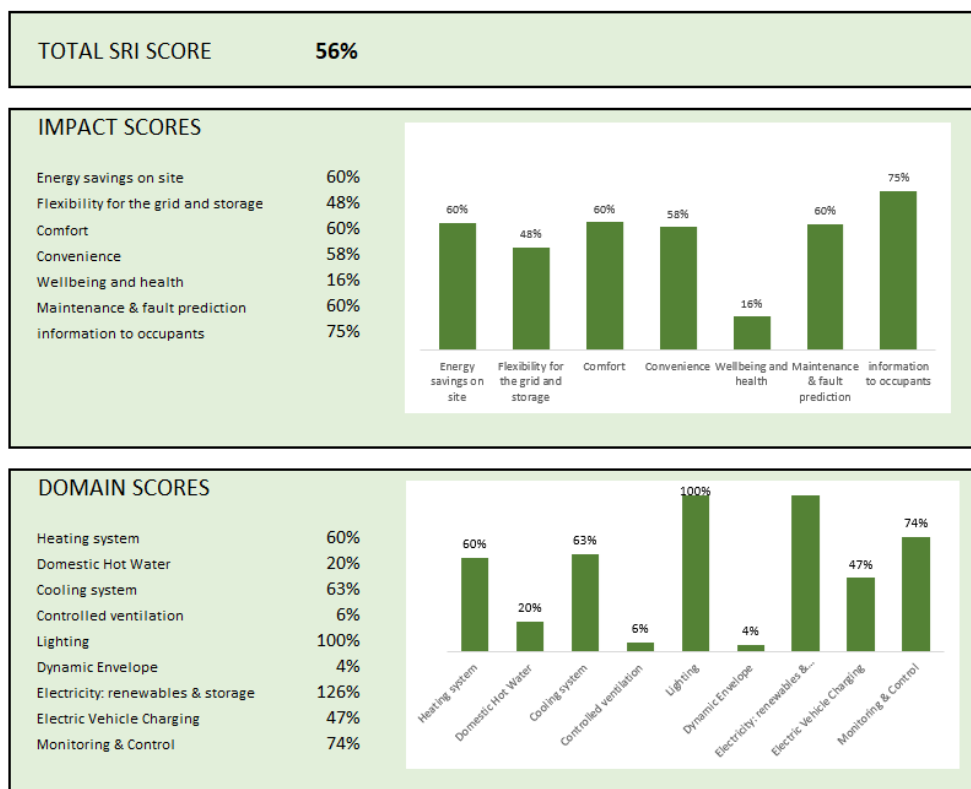
The nZEB Smart House has also been assessed by the SRI certification scheme developed by IsZEB according to the final technical study commissioned by DG Energy. Figure 24 presents the scores that it achieves at the various domains and the impact of its operation on the occupants as well as other factors (energy saving, flexibility etc.). Even though the Smart House's score at the Asset Rating scheme is the highest possible (Class A+), its SRI score is relatively lower (56%), which highlights the different aspects studied by the two certification schemes. It should be noted that the Smart House's SRI certification procedure is currently under revision and the up to date results are presented below.

Figure 24: Smart House SRI score

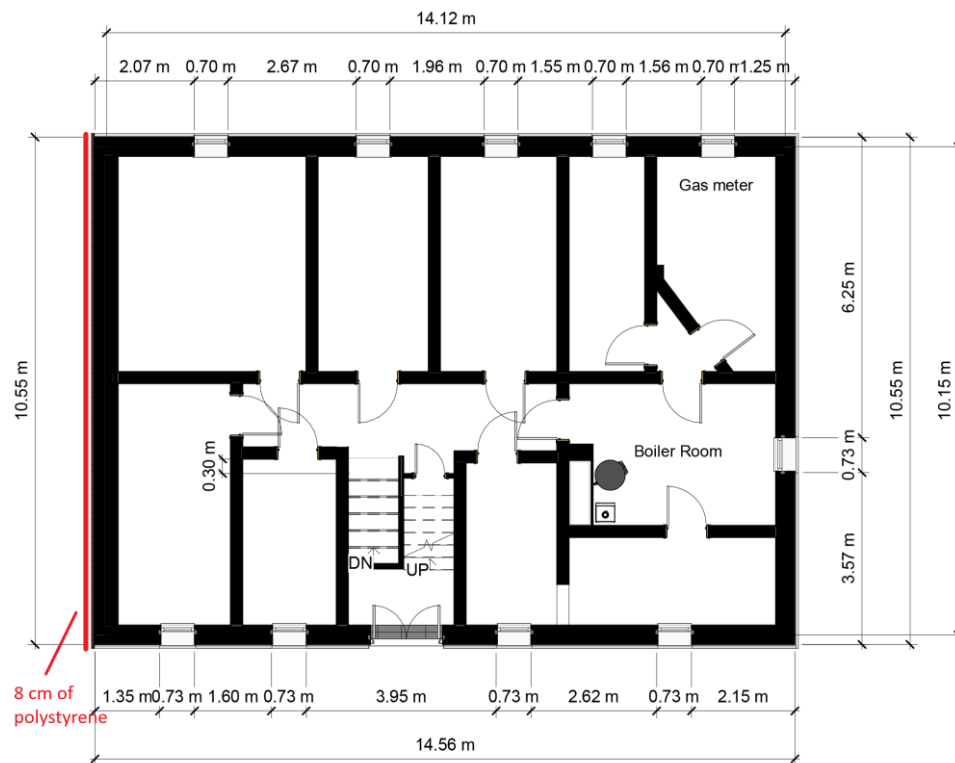
The total area of the walls in contact with the ambient air is 510.53m². All walls are made of brick, and their width is 40 cm. Only the western wall is insulated with expanded polystyrene (Figures 34-37), as this side of the building needed additional thermal protection. Data derived from the national EPC shows that the western wall's U-value is 0.39 W/(m²K) while the U-value of the other walls is equal to 1.7 W/(m²K).

Figure 34: Insulation of vertical building elements – basement

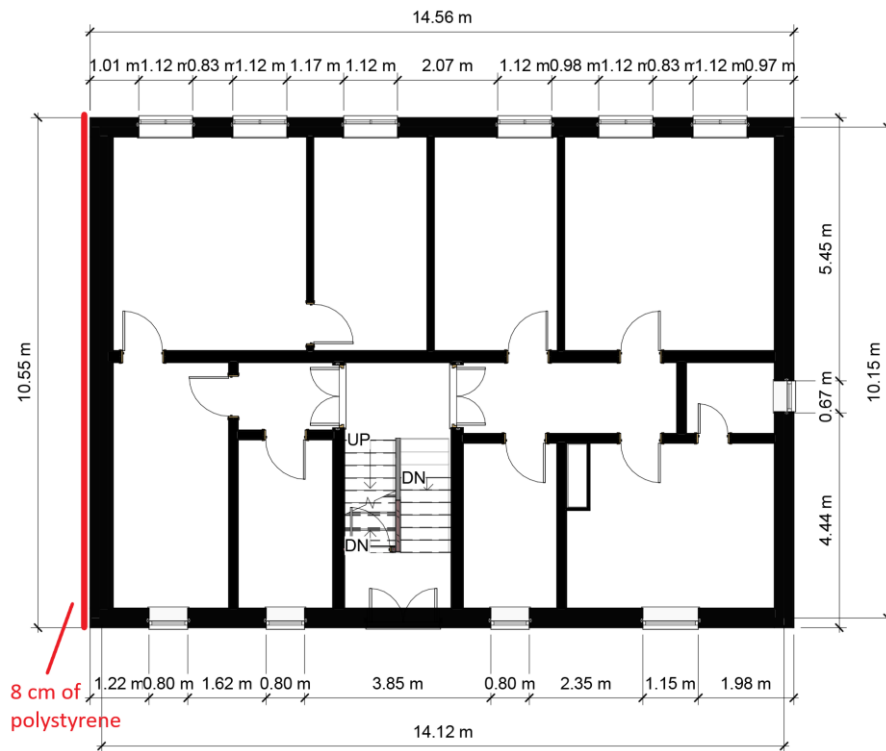
Figure 35: Insulation of vertical building elements – 1st floor

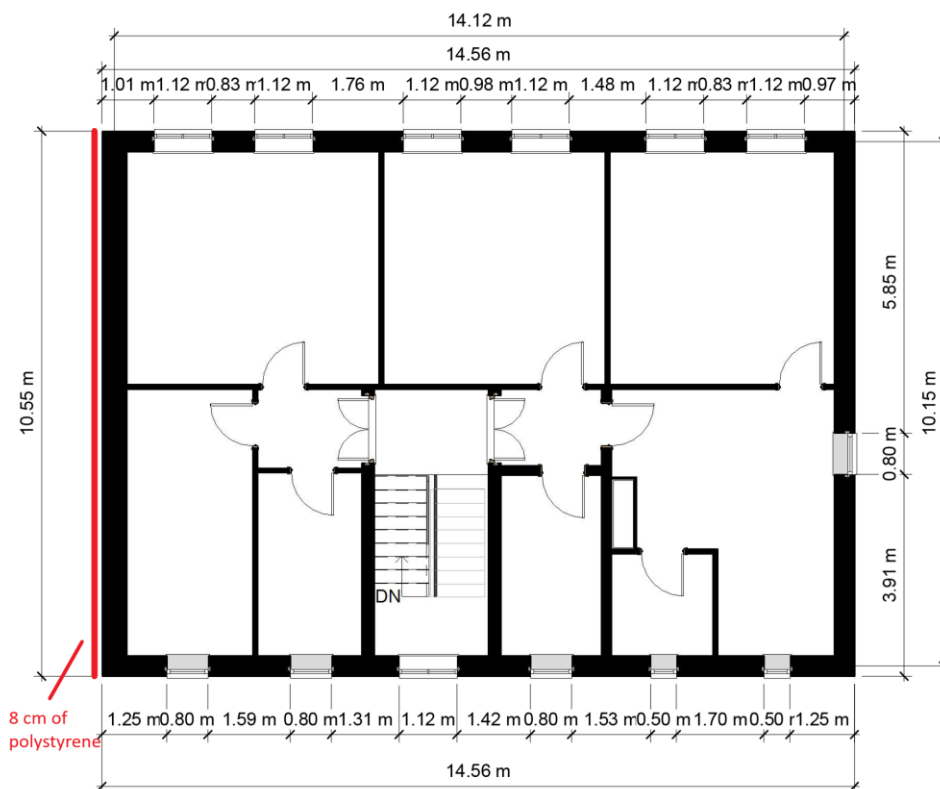
Figure 36: Insulation of vertical building elements – 2nd floor

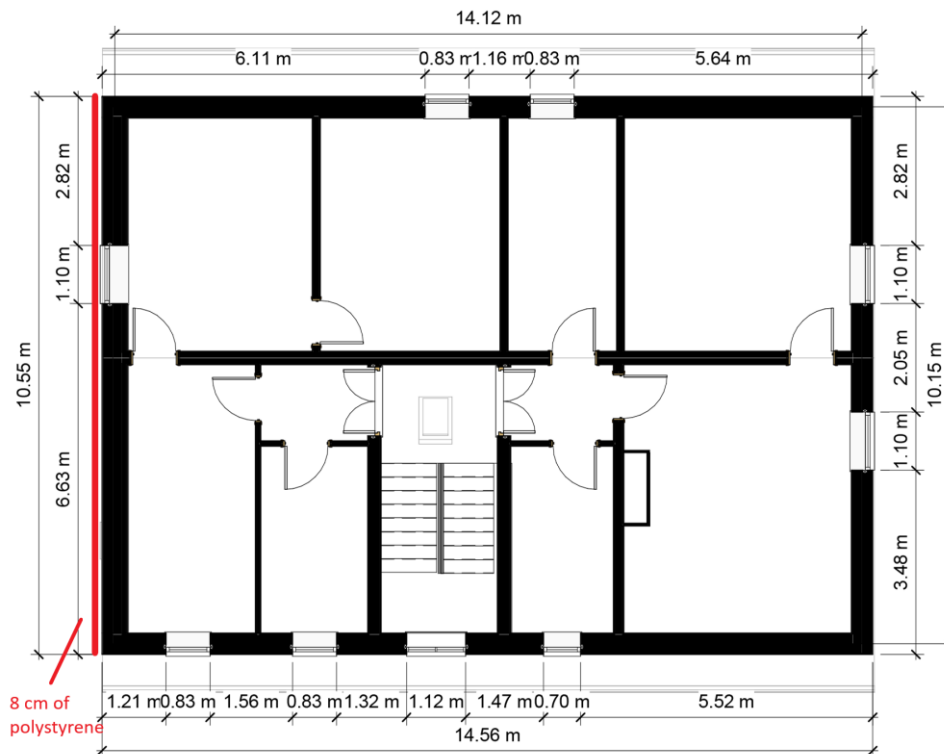
Figure 37: Insulation of vertical building elements – 3rd floor

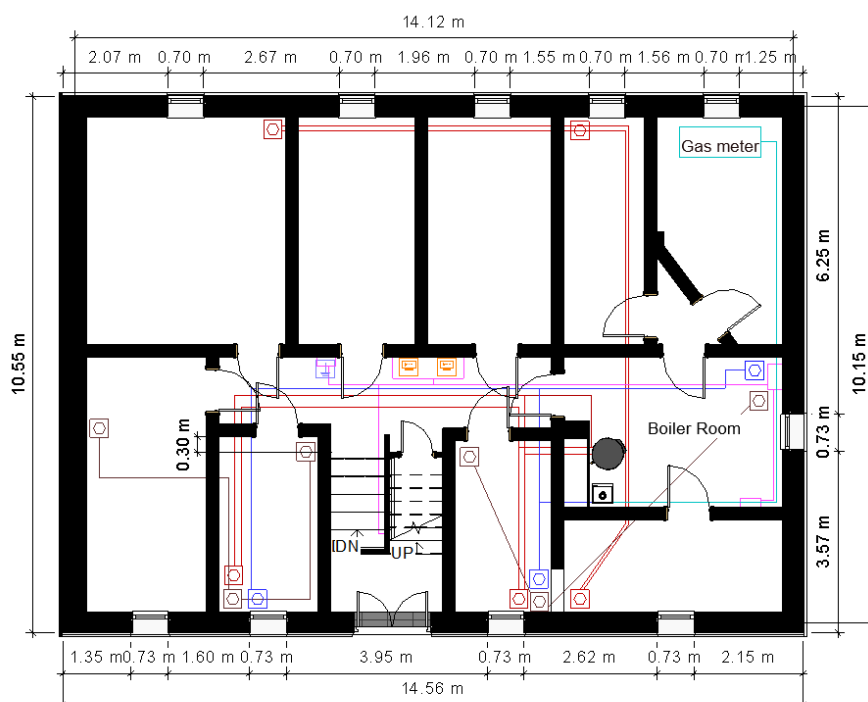
Figure 41 shows the electrical, gas and water systems in the basement of the building. The smart meters are depicted with the icons in orange color while the gas meter is marked with the light blue color. Currently, no sub-meter device has been installed to monitor gas consumption.

Figure 41: Electrical, gas and water systems - Basement

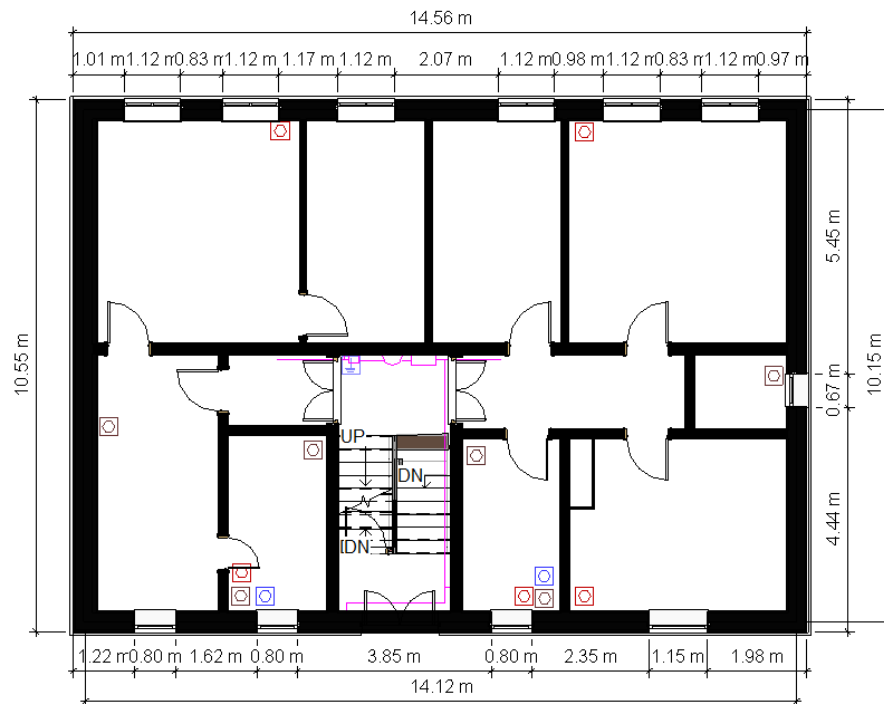
Figure 42: Hot, cold water supply and sewage stack - 1st floor

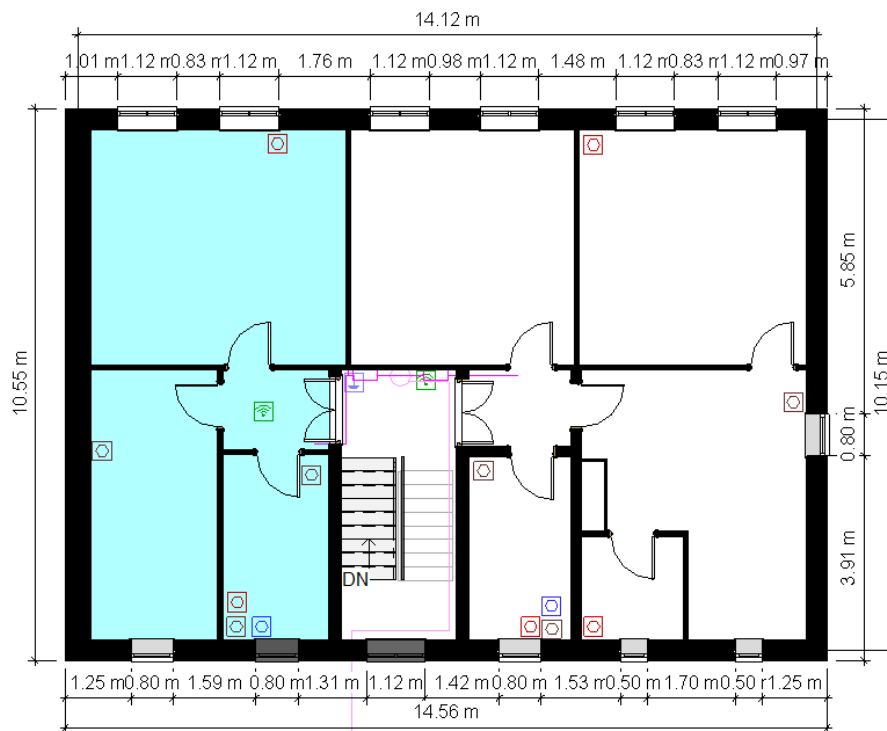
Figure 43: Hot, cold water supply and sewage stack as well as sensors location - 2nd floor

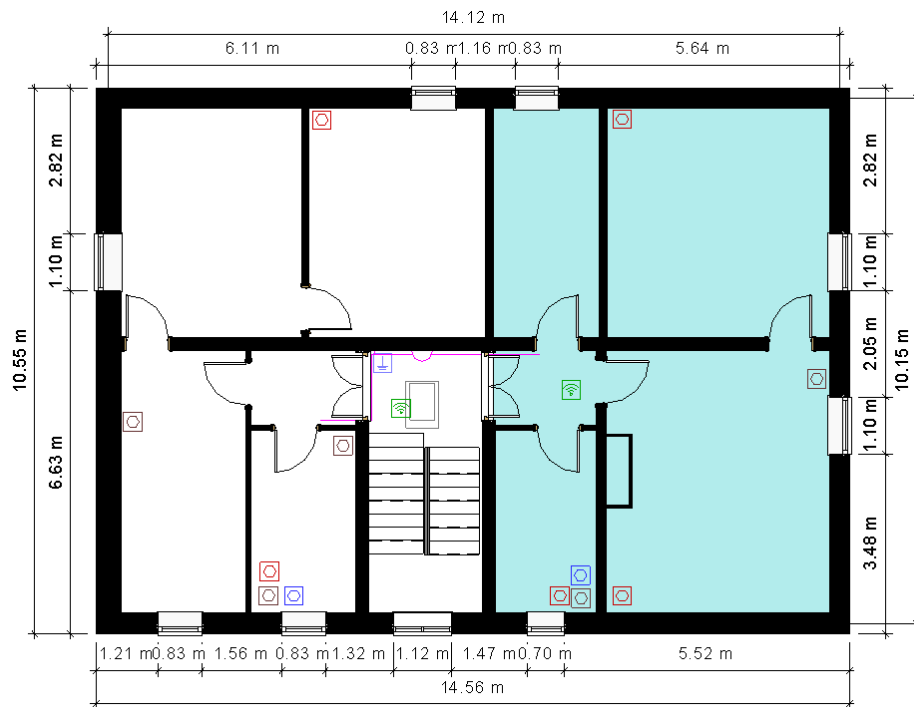
Figure 44: Hot, cold water supply and sewage stack as well as sensors location - 3rd floor

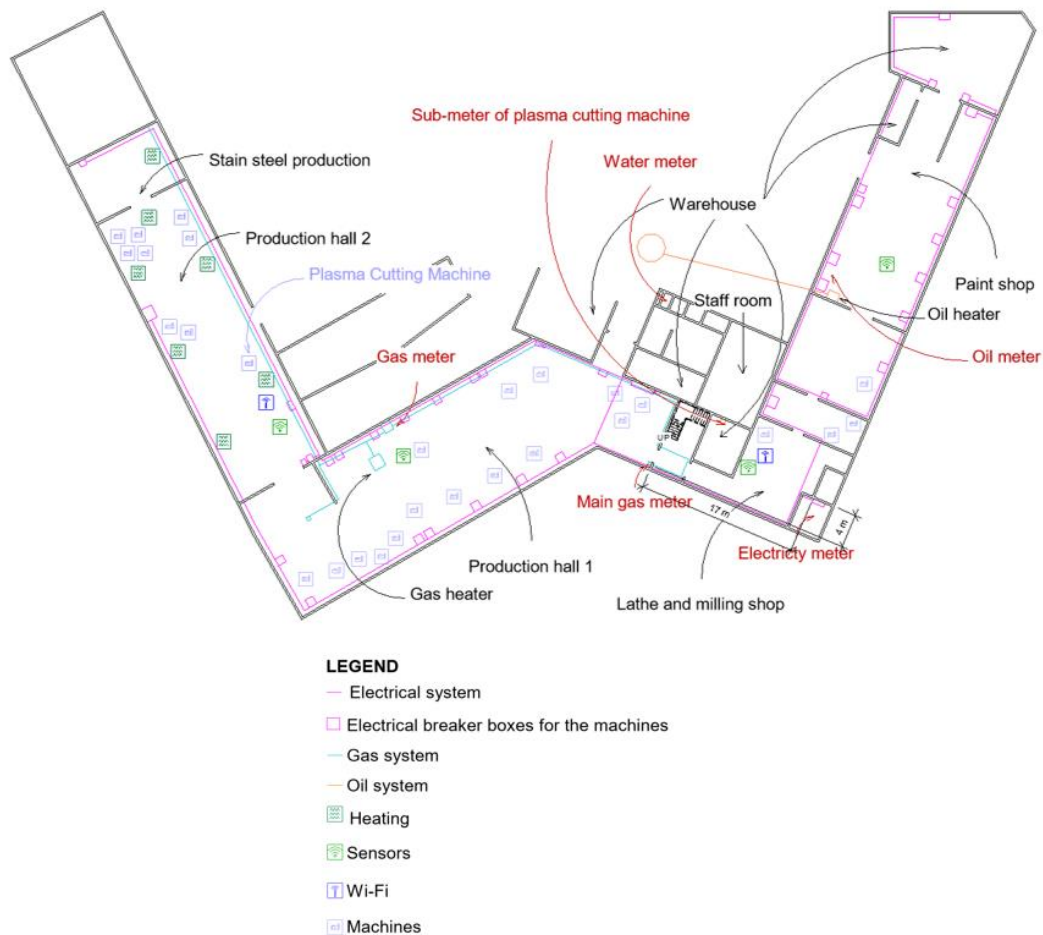
Figure 59: Case Study #3 - Electrical, gas and heating systems as well as sensors location

The location of the equipment on the floor map of the building is available in Figure 59.

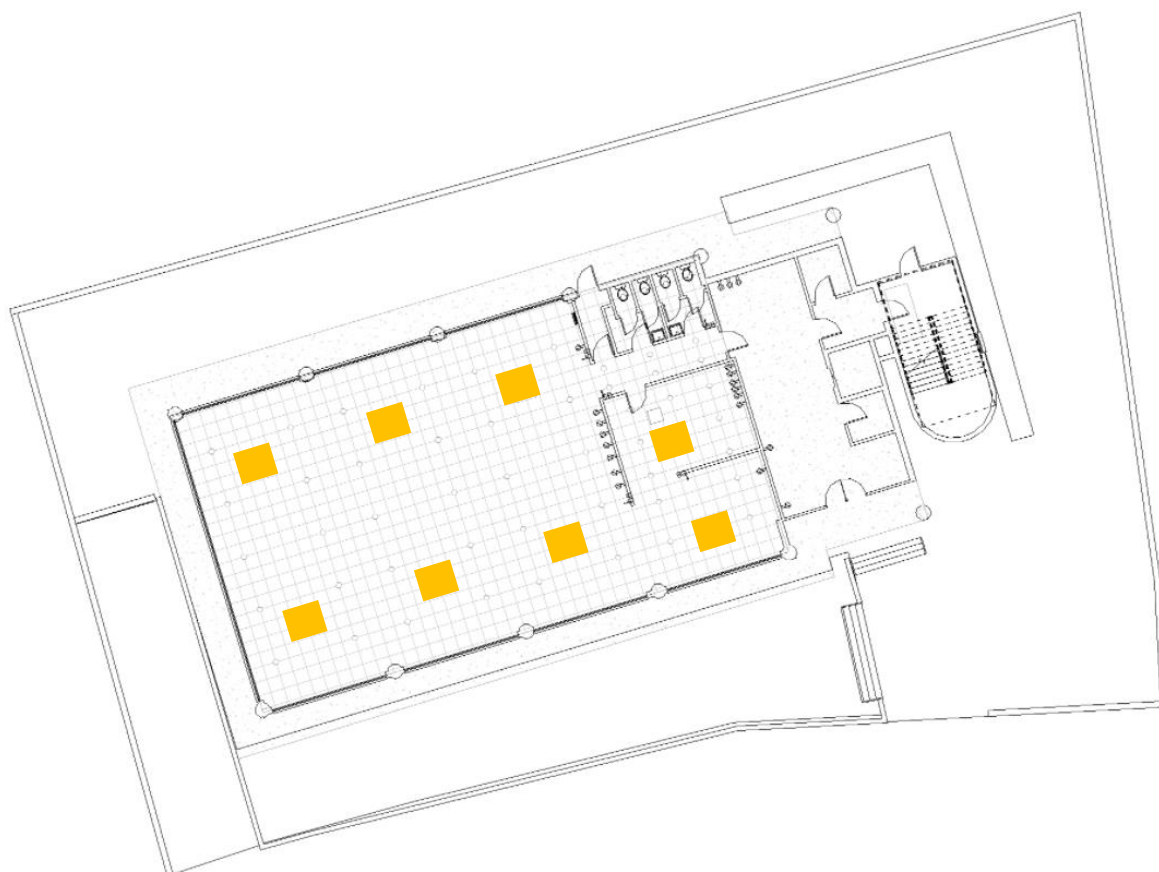
Figure 83: Ground floor HVAC

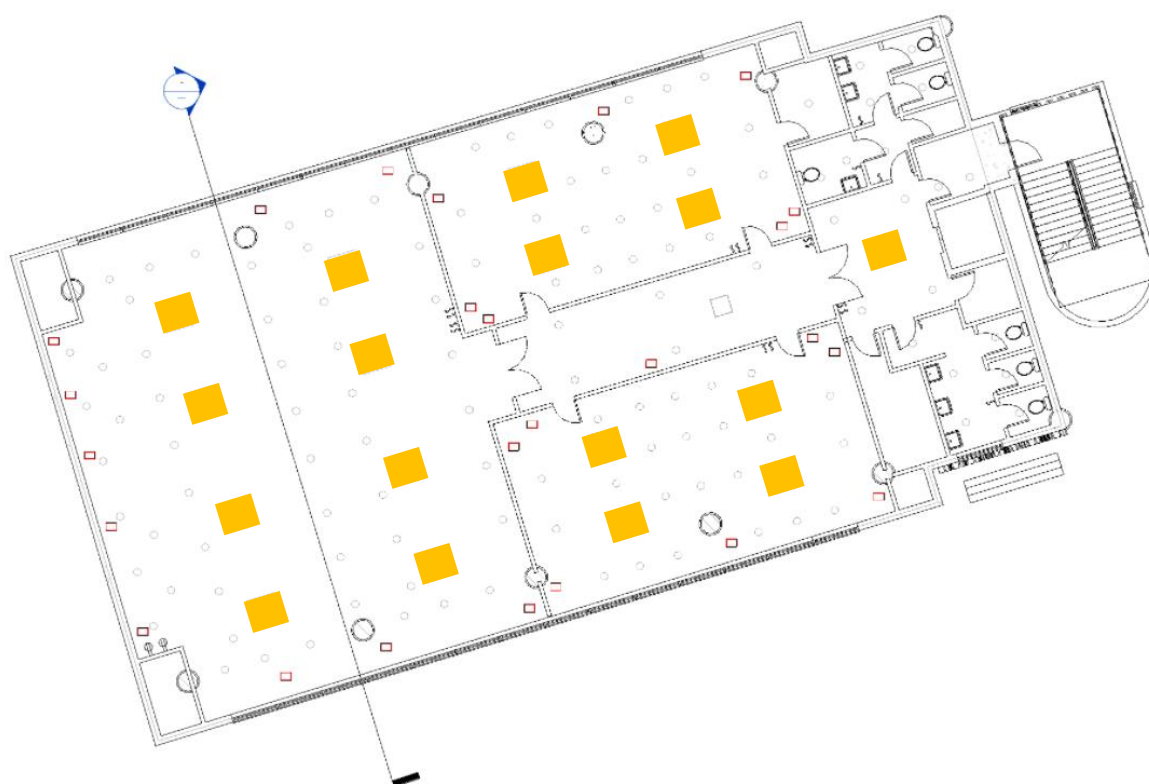
Figure 84: First floor HVAC

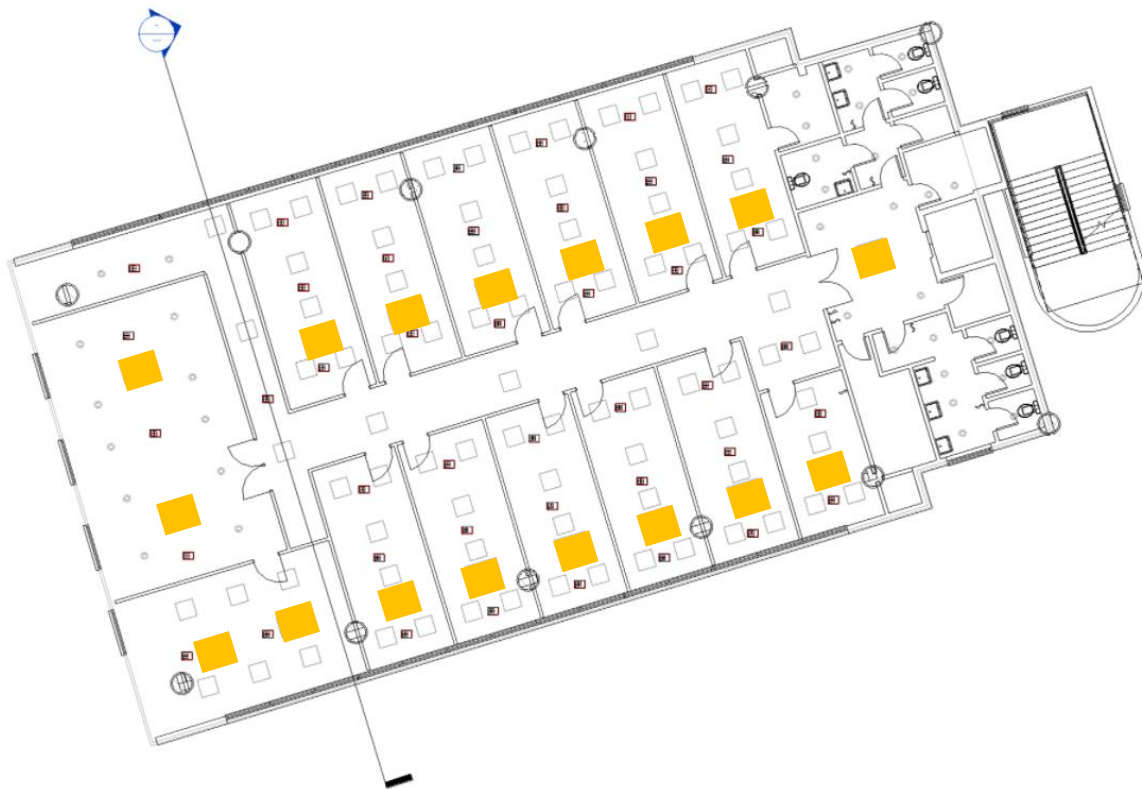
Figure 85: Second floor HVAC

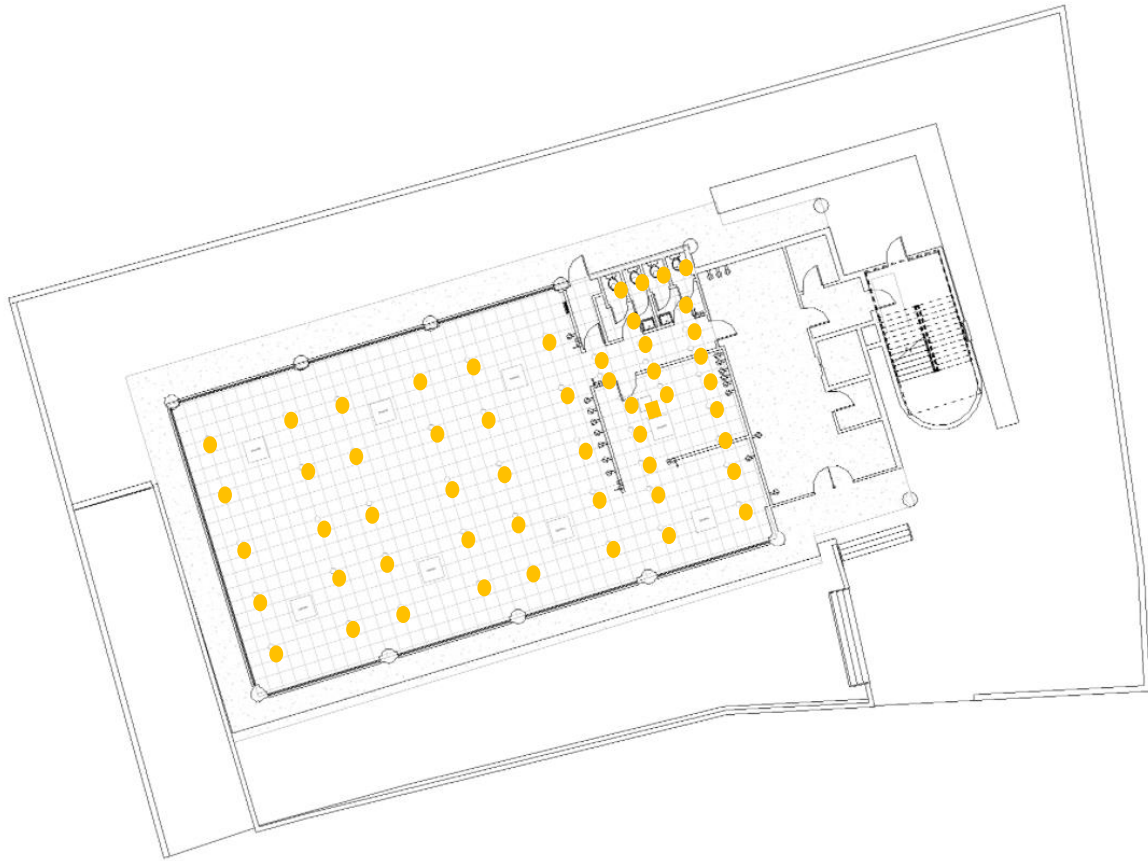
Figure 86: Ground floor lighting

The lighting installation has two system types in the two floor spaces according to their use. The lighting requirements at the office spaces are more demanding. Thus, 86 square LED panels of 60x60cm have been installed in total, 1 on the ground floor and 85 in the offices on the second floor. Each panel has crosswise parabolic louvres and longwise double parabolic elements. Their shape is rectangular with dimensions, 600x600x95mm. Every device includes 4 LED lamps (fluorene type T8) with a power consumption of 10W each. In the seminar hall spaces, and common use areas, a total of 209 spotlight lighting units have been installed, 53 on the ground floor, 123 on the first floor and 33 on the second floor, respectively. Each spot is equipped with 2 LED lamps of 10 W each. Furthermore, the emergency lighting includes 4 EXIT LED (2 W). They are equipped with Ni-Cd batteries that are capable of providing lighting for 2 hours. The total power consumption of the building's lighting system is calculated to be equal to 1314 kWh per month. The deployment of the lighting equipment is presented in Figure 86, Figure 87 and Figure 88.

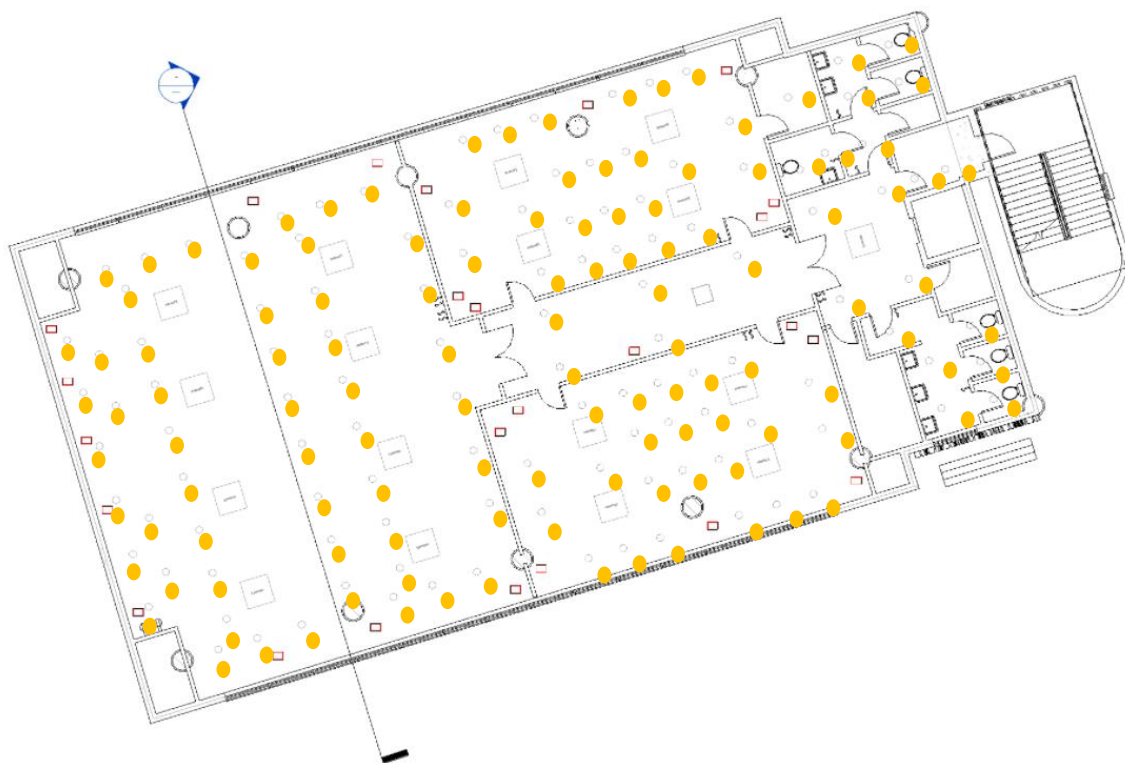
Figure 87: First floor lighting

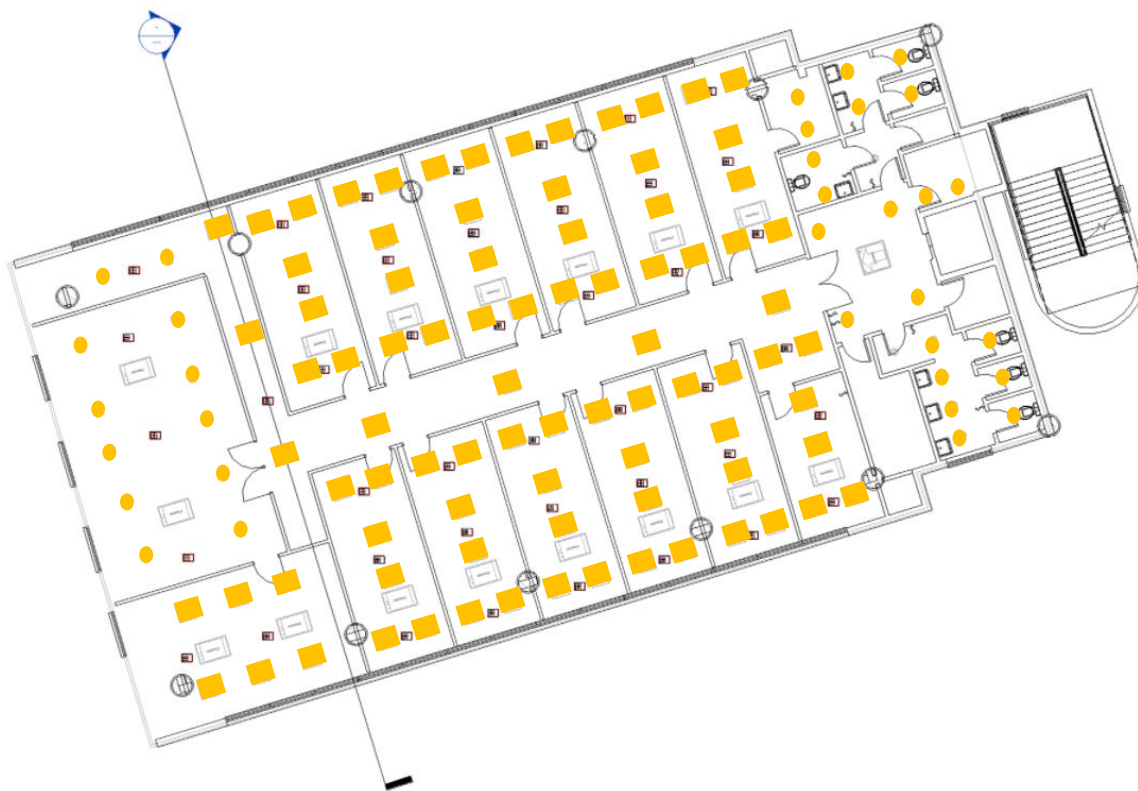
Figure 88: Second floor lighting

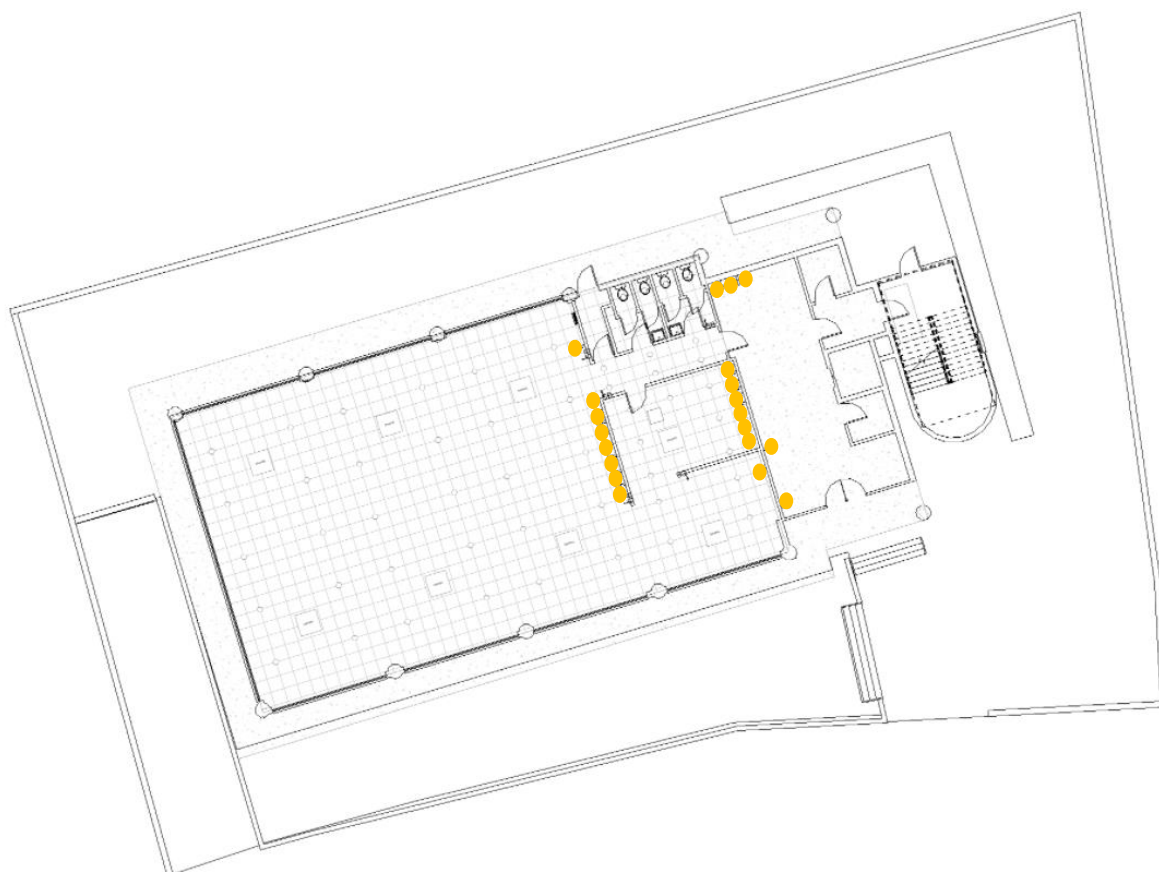
Figure 89: Ground floor power socket wall duplexes

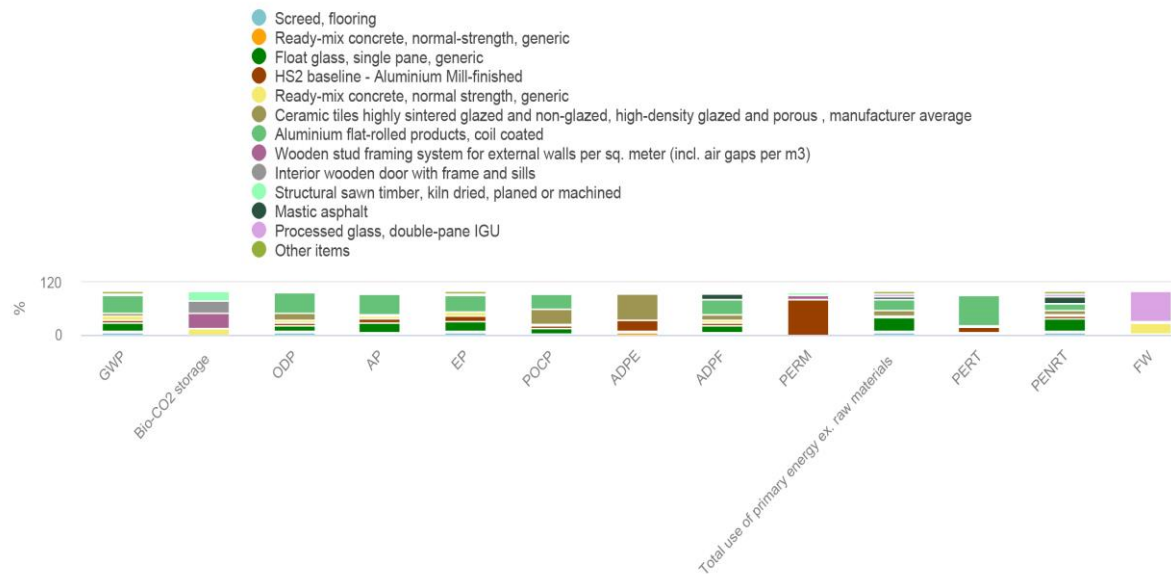
Figure 92: Graph of the values of environmental indicators for each building material

Through the values is observed the environmental footprint for each construction material and each category of structural element (Table 29 and Table 30).

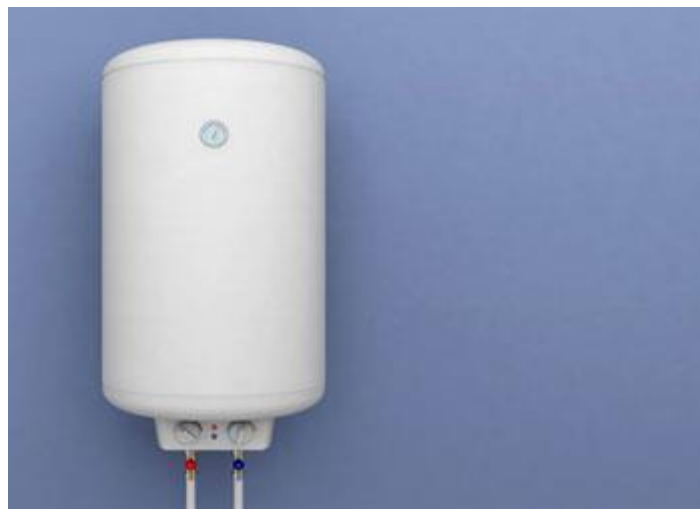
Typically, in the kitchens there is an additional smaller domestic hot water tank having a volume of 5 L and a maximum power of 1.5kW. Those units are switched on during the whole day, providing a constant DHW temperature. However, some individual improvements may have been made in the recent past years.

Figure 106: Typical older DHW tank

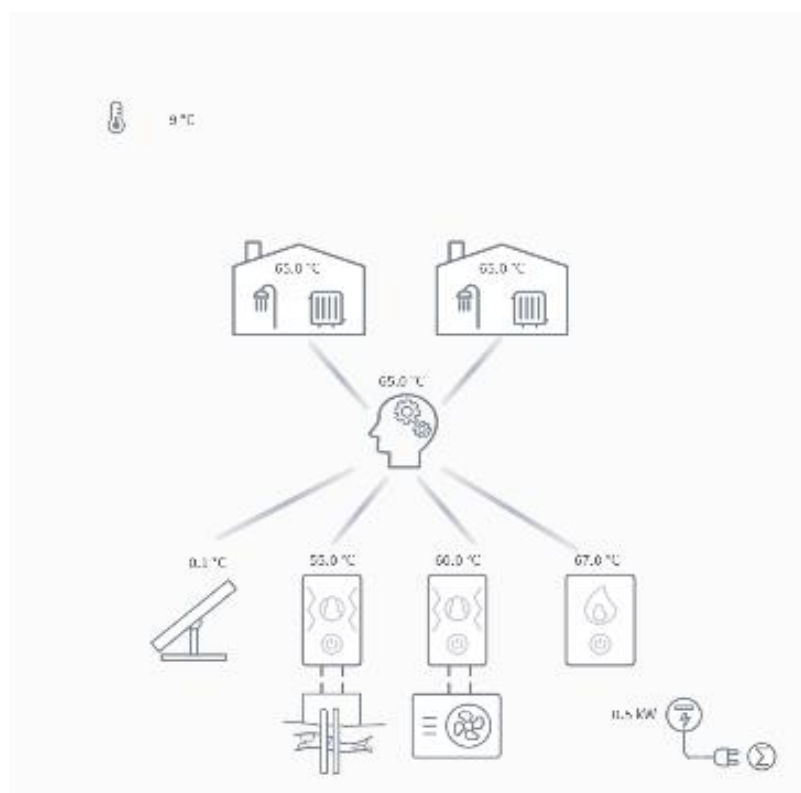
The information about the total heating demand can be acquired from the energy monitoring tool, which is provided by an external party (GREEN FUSION start-up company) and also offers the possibility of AI-optimization. The system integrates information from power, heat and gas and allows an actual view into the energy flows of the central HVAC. It also shows the actual status of the valves and the temperatures in a HVAC plant diagram. There is yearly information about the individual energy demand in the apartments.

Figure 108: Overview of the Energy Monitoring System

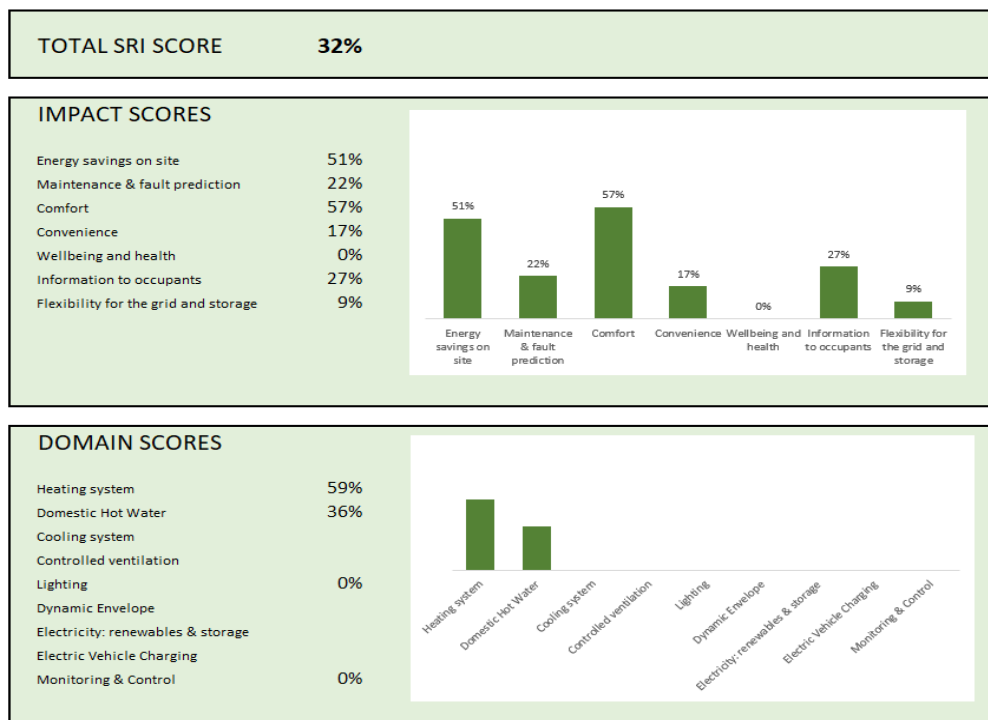
Figure 110: SRI assessment results

The results of the SRI assessment are displayed in Figure 110 below.

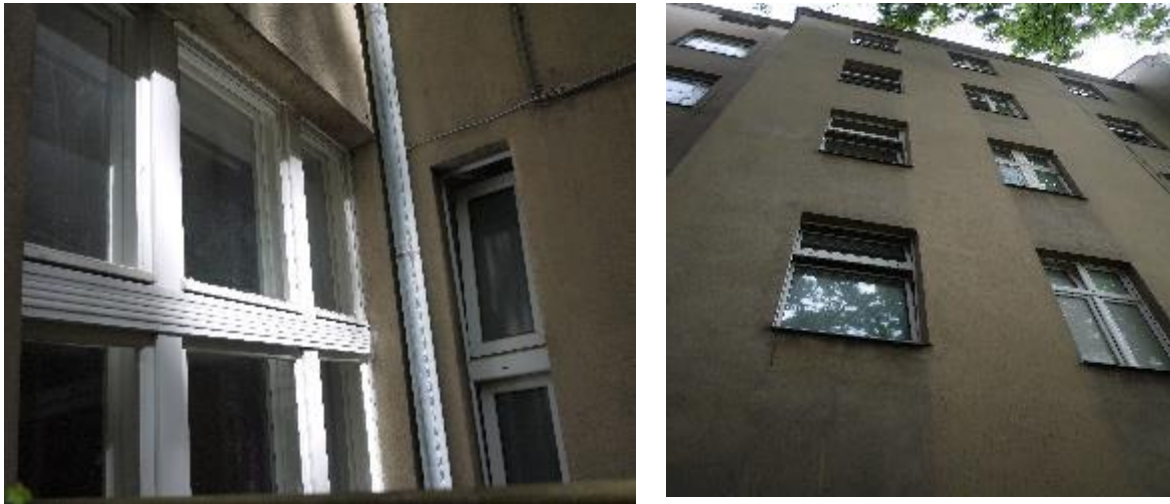
Figure 113: Window details
