Project Acronym: D^2EPC

Project Full Title: Next-generation Dynamic Digital EPCs for Enhanced Quality and User Awareness

DELIVERABLE D5.3

Pilot Planning and Setup v1

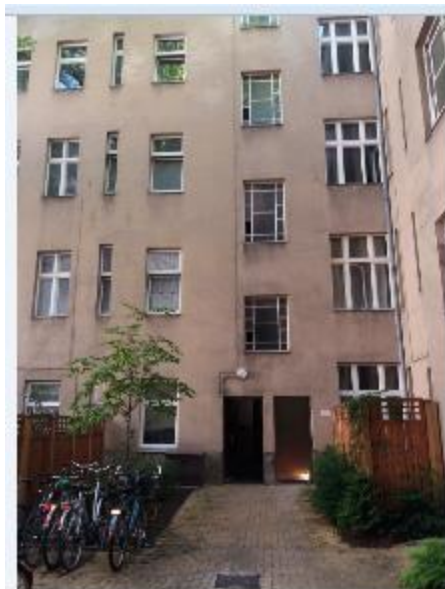
The windows were partially replaced by plastic windows, having special heat insulation glazing. Single glazing is seen in the windows of the staircases with an U-value of $5.1 \text{ W}/(\text{m}^2 \text{ K})$. No geometrical shading is present apart from the neighbouring buildings and some vegetation.

Figure 120: Box double windows

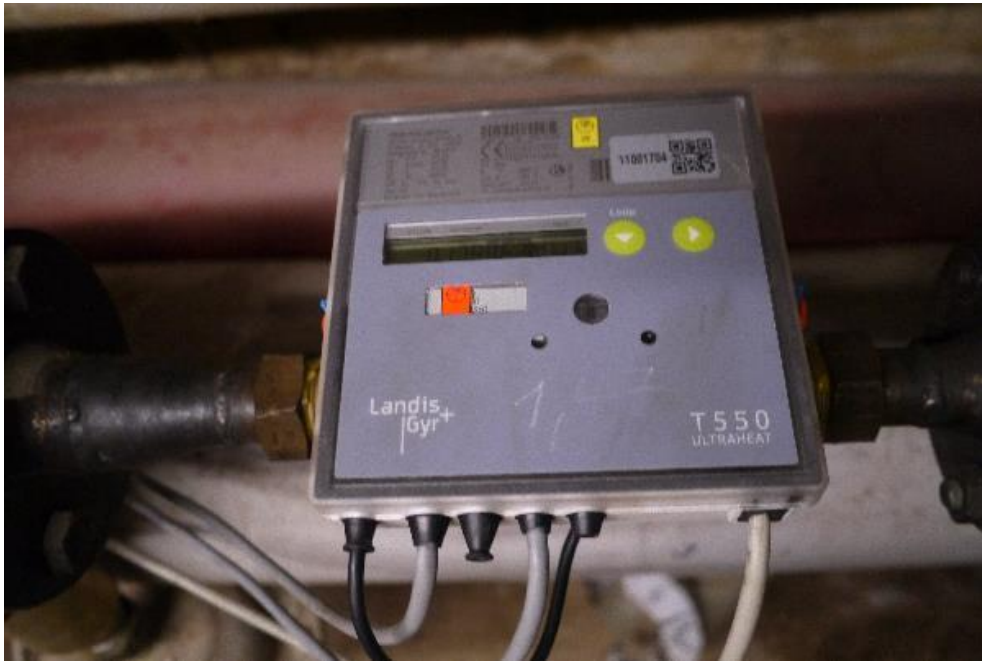
Figure 122: Heat meter

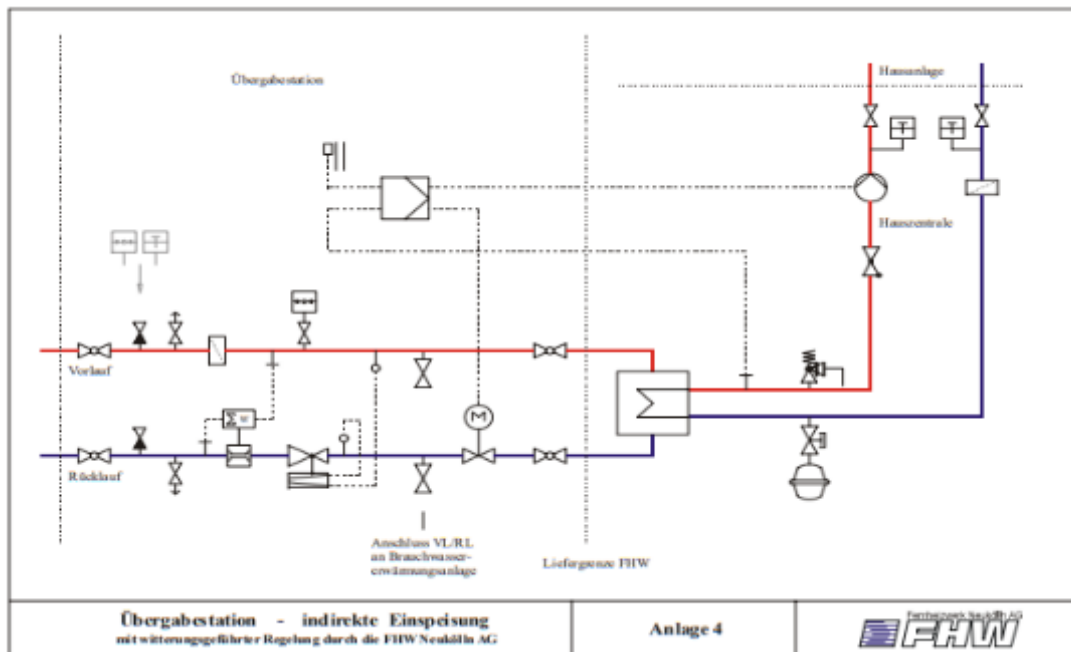
The district heating network runs at 110°C/55°C, the heating system heating system at 70°C/55°C in the design case for an ambient temperature of -14 °C.

Figure 123: District Heating Transfer station scheme

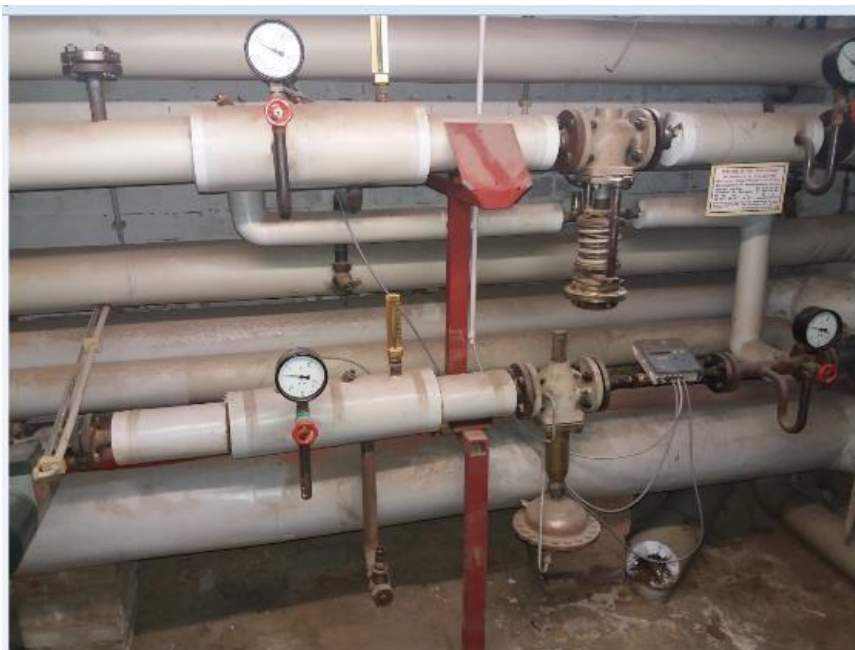
Figure 124: District heating transfer station
